The Missile's not Pinned!

By TSgt Deryk Johnston, Nellis AFB, Nev.

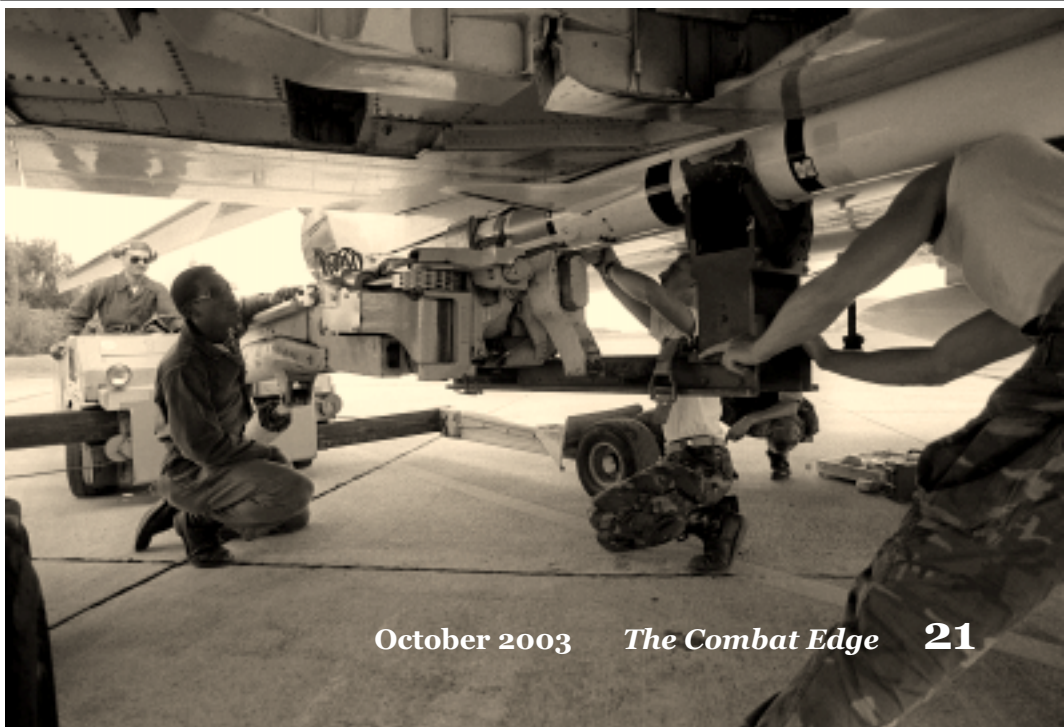
the #2 person didn't assist in the positioning of the missile, like his regular #2 person always did. In addition, the new #2 person failed to properly lock the forward missile lug. As a result, the front hook was sitting on top of the lug and pushing down on the missile instead of being properly locked! Luckily the aft hooks had caught the missile. These hooks were the only things holding the missile in place.

To further complicate the situation, the new #2 person failed to install the safety pin in the proper mechanical locking hole. The pin was mistakenly installed into a missile launcher side plate cutout. Unaware of the improperly loaded missile, the load crew proceeded to finish up on the other side of the aircraft.

On a post-loading inspection I noticed the forward missile lug wasn't properly locked.

craft when I noticed that the forward missile lug wasn't properly locked in. Upon further investigation, I noticed the safety pin was not installed. My heart stopped (at least it seemed that way) as I realized that this missile was as close to falling off the aircraft as it could possibly be. I quickly pinned the missile and immediately called the crew over to reload the missile.

As you can see, attention to detail is vital. This potentially disastrous incident would have been avoided if the #1 load crew chief had ensured the #2 person knew what was expected of him during the load operation. Also, the #1 load crew chief should've had the self-discipline to follow his loading checklist to ensure the missile was properly post loaded.
